INVESTIGATION OF THE INTERNAL ROOM FIRE CHARACTERISTICS OF A 5-MIL THICK REINFORCED PVC MEMBRANE CEILING TESTED IN GENERAL ACCORDANCE WITH UBC STANDARD 26-3, "ROOM FIRE TEST STANDARD FOR INTERIOR OF FOAM PLASTIC SYSTEMS"

FINAL REPORT

SwRI Project No. 01.03050.01.211a[1]

Newmat USA
25 Surryhill Place
Huntington, New York 11743

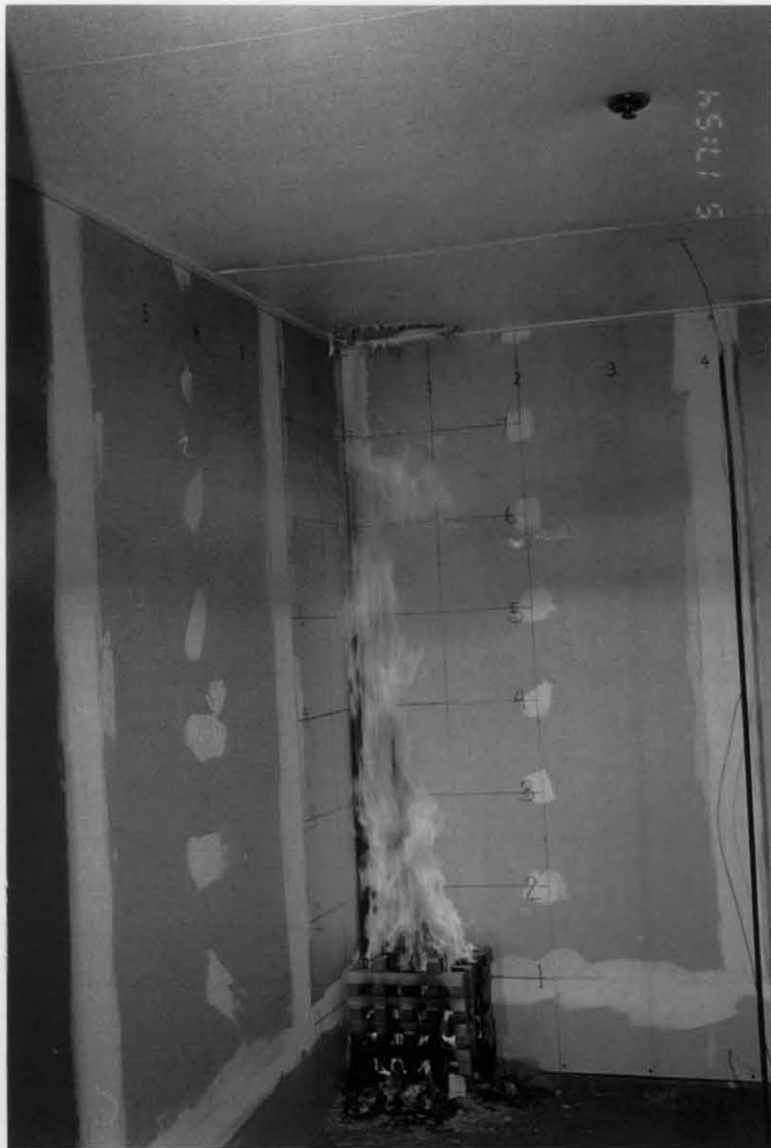
01:42	Slight discoloration on the reinforced ceiling membrane in the crib corner.
02:00	Melt-thru of the reinforced PVC membrane directly in the crib corner.

02:16	The hole, which has developed in the crib corner on the reinforced PVC membrane, is now approximately 12 in. in diameter. A white smoke is beginning to develop in the room interior.

Figure B-5. View of Crib Corner with Melt-Through of Reinforced PVC Membrane at the Crib Corner. Note: Layer of Smoke in Room Interior. Test Time Is Approximately 2 Min.

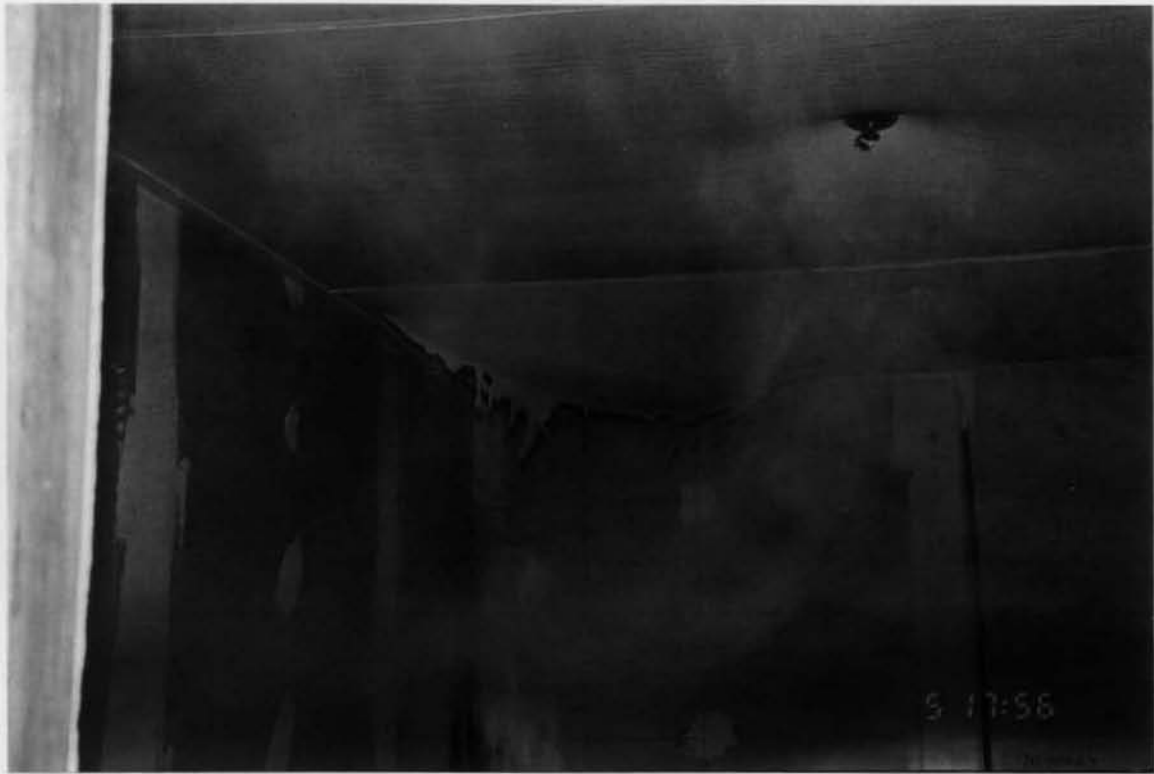
Figure B-6 View of Test Corner and Ceiling. Reinforced PVC Membrane Is Beginning to Sag at Crib Corner and Around Sprinkler Head.

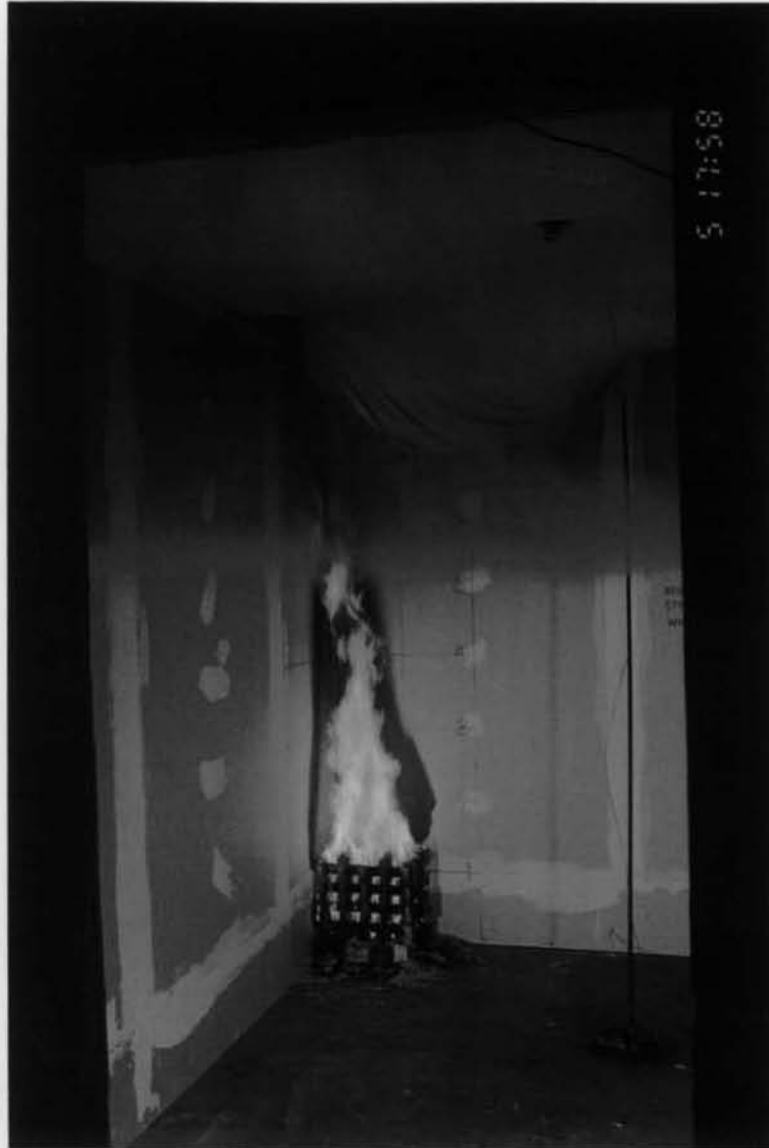
Figure B-7. Room Interior at Approximately 6 Min into Fire Exposure. Reinforced PVC Membrane Is “Hanging Down” Approximately 18 In. (6½ Ft from Floor).

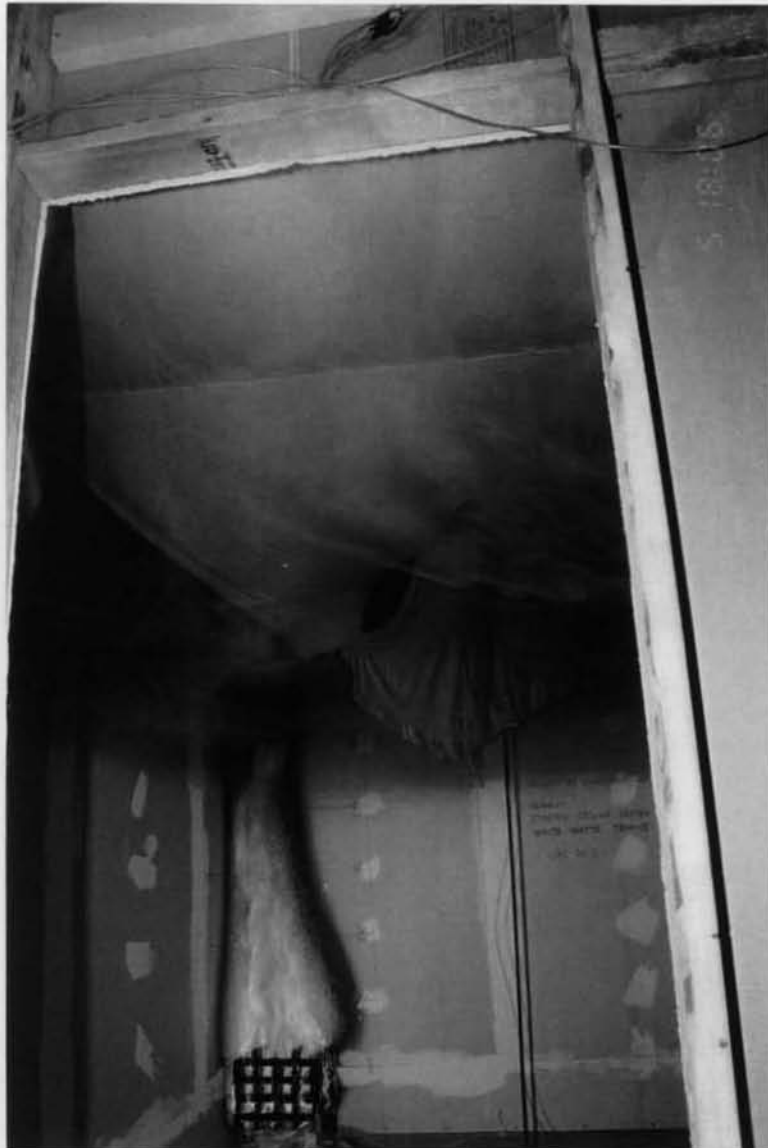
- 14:00 The reinforced PVC membrane has pulled away from the aluminum angle trim 7 ft from each wall away from the crib corner. Flames from the crib are 6 to 6½ ft above the floor.
- 14:55 The reinforced PVC membrane has pulled away from the aluminum angle trim 8 ft from each wall away from the crib corner, and is hanging downwards 5½ ft above the floor. Flames from the crib are 5½ ft above the floor.
- 15:00 End of 15 min fire exposure, crib extinguished.

Figure B-9. Room Interior at Approximately 14 Min into 15-Min Fire Exposure. Reinforced PVC Membrane Is “Hanging Down” Approximately 2½ Ft Down from 8-Ft Ceiling (5½ Ft Above the Floor).

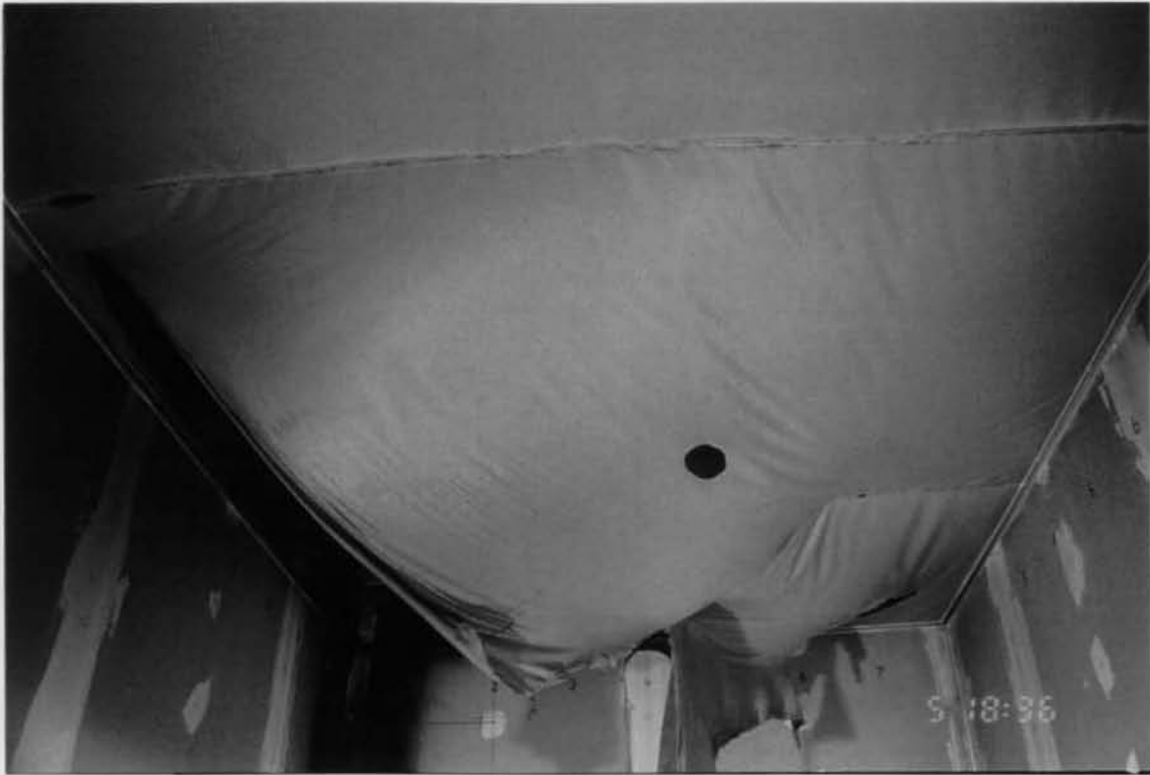
During the initial course of the 15-min fire exposure, flames and heat from the burning crib softened and melted the reinforced PVC membrane initially forming a small hole to develop in the ceiling corner. All four sprinkler heads installed in the room interior activated. By the end of the 15-min fire exposure, the reinforced PVC membrane melted/tore away in the crib corner approximately 8-ft along both walls which formed the crib corner, and hung down 5½ ft above the floor.

Figure B-10. Reinforced PVC Membrane Ceiling at End of 15-Min Fire Exposure. Membrane Has Torn from Angle Trim 8 Ft Along both Walls.
