Western Fire Center, Inc.

Test Report on the Performance Evaluation of Sprinkler Heads in a Full Scale Room Construction: Modified AC 171

WFCi Report #04025

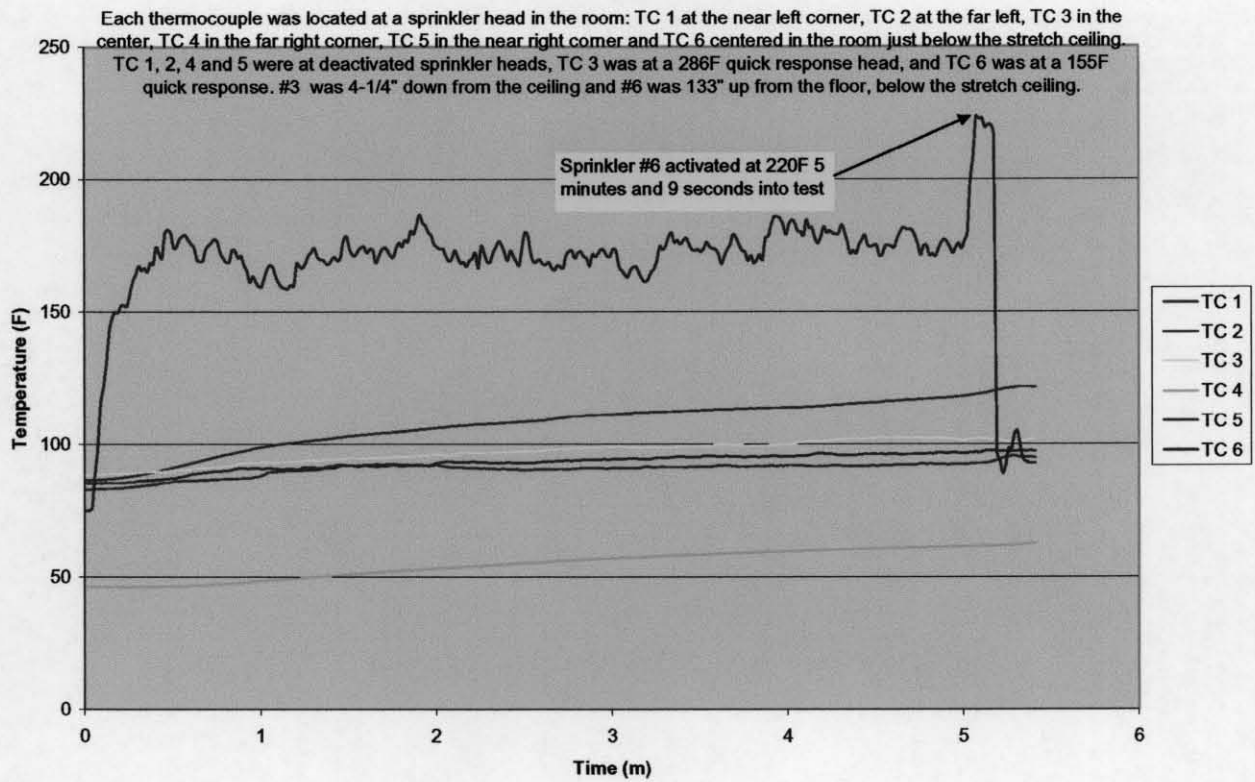
New Mat Test Thermocouple Temperatures

Temperature data obtained from the thermocouples appears in graphical form in Appendix A of this report and in tabular format in the Test Results section of this report.

Time (m)	TC1 (F)	TC2 (F)	TC3 (F)	TC4 (F)	TC5 (F)	TC6 (F)
0	82.9	86.5	88.4	46.4	85.3	74.8
1	88.1	98.9	93.1	48.4	90.8	159.5
2	92.1	106.1	96.2	53.2	93.0	174.4
3	91.0	111.1	99.0	57.0	94.5	173.6
4	92.2	113.7	99.9	59.6	95.3	182.8
5	92.5	118.1	101.7	61.7	96.7	176.6
5:09	93.3	119.7	101.9	61.9	97.6	220.3

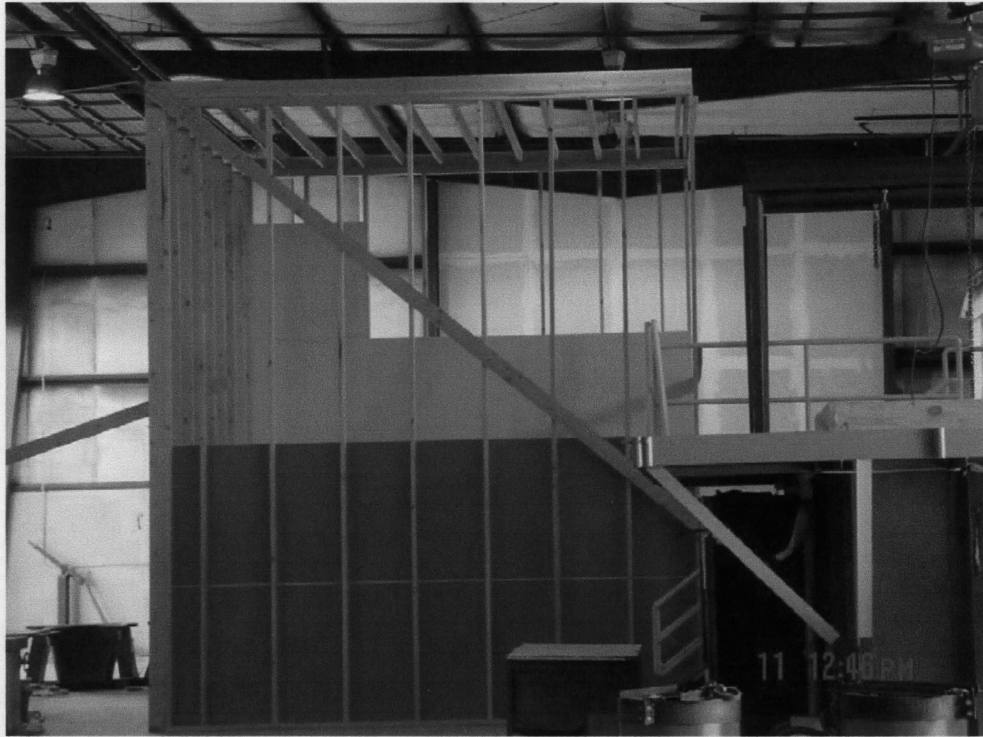
Photo 1: Room Being Constructed.

The room constructed for the sprinkler evaluation test was a 15' X 15' X 18' wood stud construction. The interior of the construction was covered with 5/8" type X gypsum wallboard.

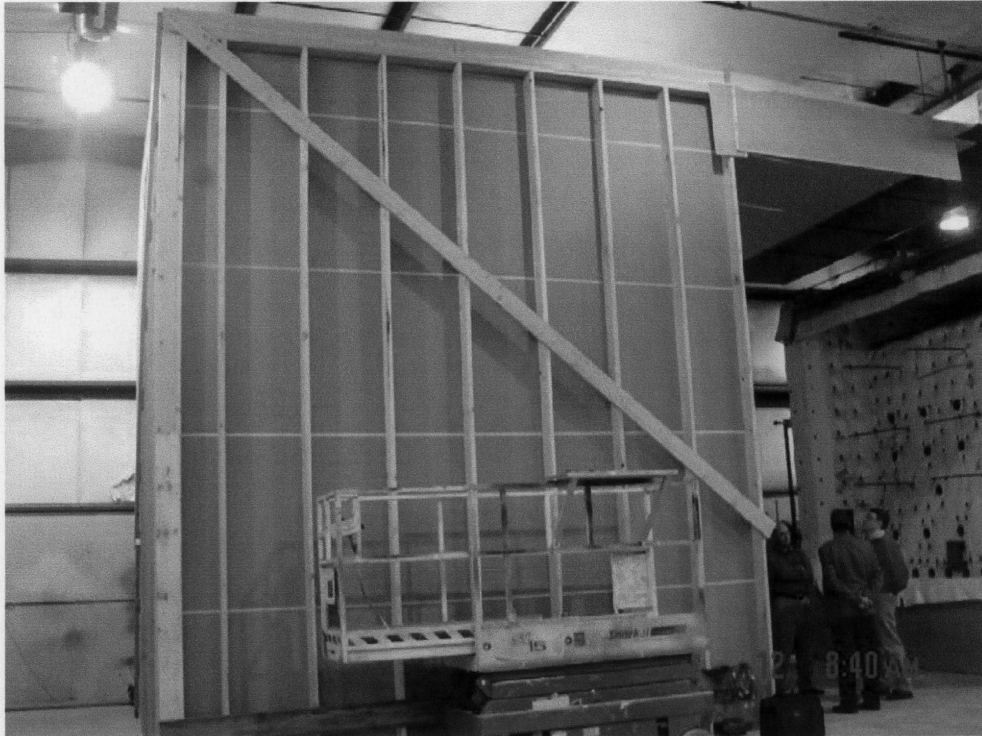
Photo 3: Room Construction Complete.

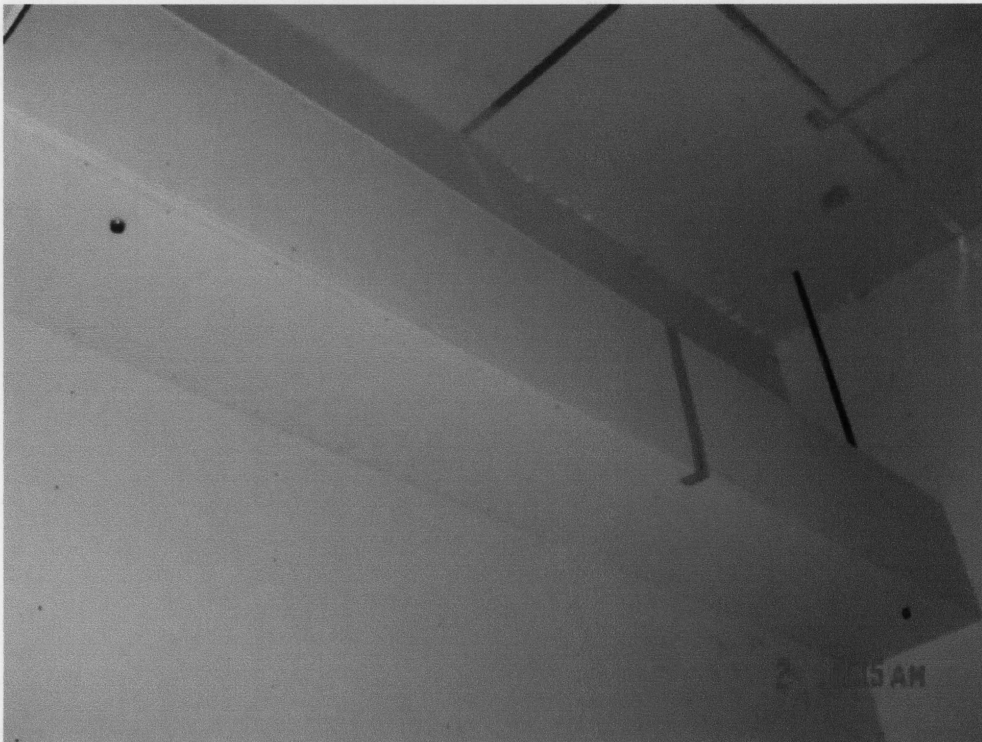
Photo 4: Soffit on Left Side of Room: Sprinkler #1 on the Left and #2 on the Right.

Two 2' X 2' soffits made of 5/8" type X gypsum were added running along each side wall of the room 11'-6" up from the floor. Sprinkler heads 1, 2, 4 and 5 were attached to pipes that came down from roof of the room and through these soffits, ending up 11'-1.5" above the floor. Sprinkler #1 was located 1.5' in from the left wall and 1' in from the front of the room, #2 was located 1.5' in from the left wall and 1' in from the back wall, #4 was located 1.5' in from the right wall and 1' in from the back wall, #5 was located 1.5' in from the right wall and 1' back from the front of the room. Sprinkler #3 was centered in the room, 7'-6" in from each wall and 4¼" down from the ceiling. These sprinkler heads were all located above the stretch ceiling material during testing. Sprinkler #6 was also centered in the room, 7'-6" in from each wall and 83" down from the ceiling, below the soffits and the stretch ceiling material.

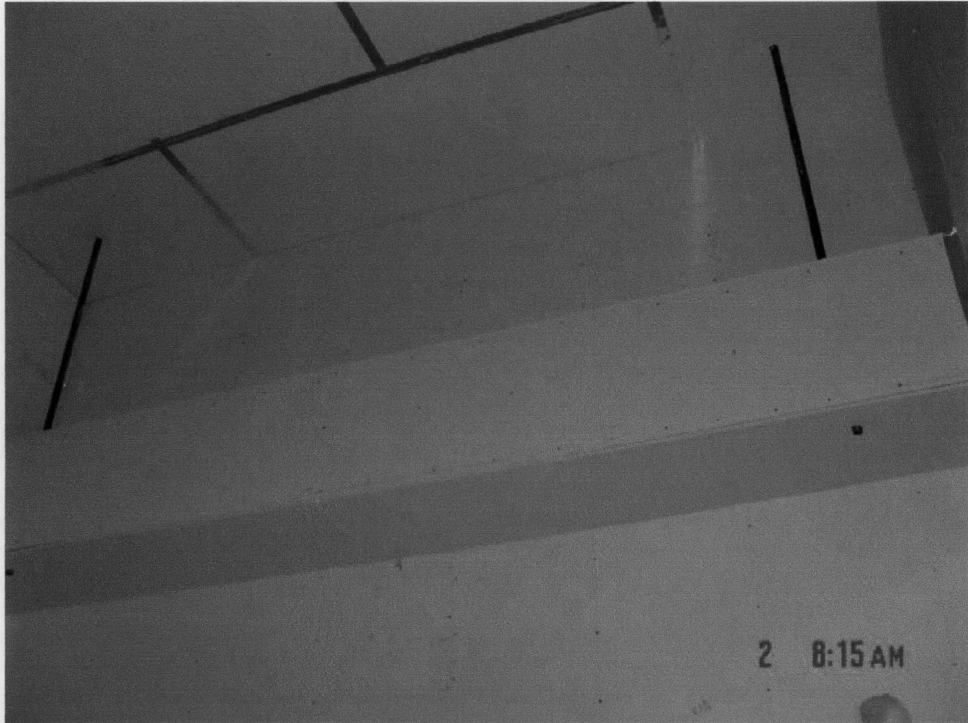
Photo 5: Soffit on Right Side of Room: Sprinkler #4 on the Left and #5 on the Right.

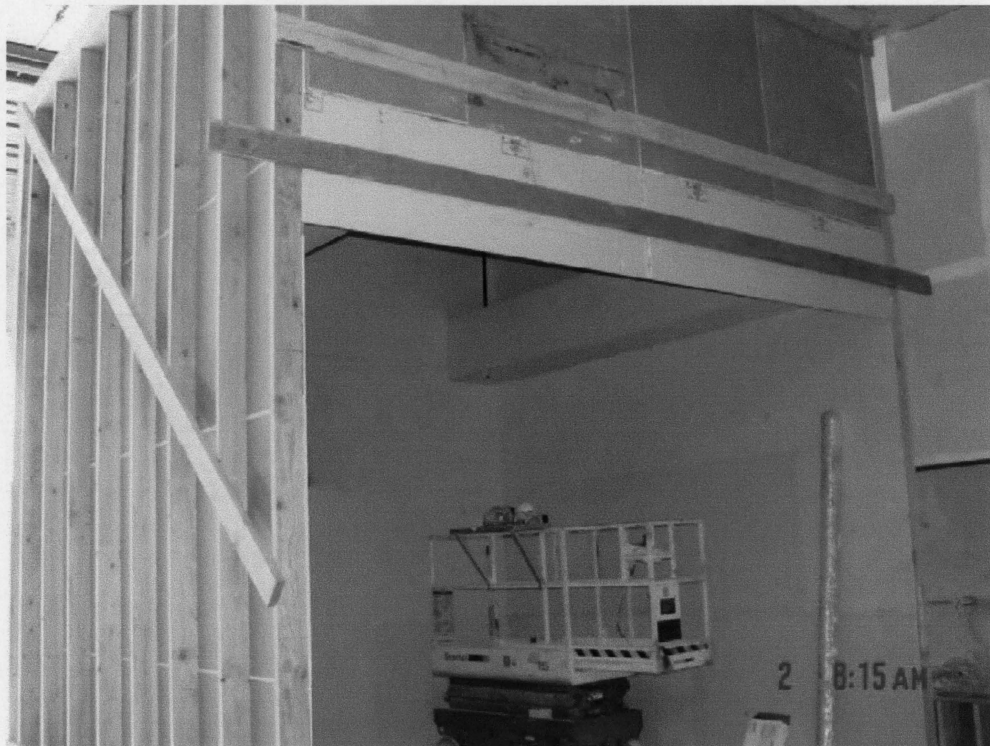
Photo 6: Front View of Room with Soffits Installed.

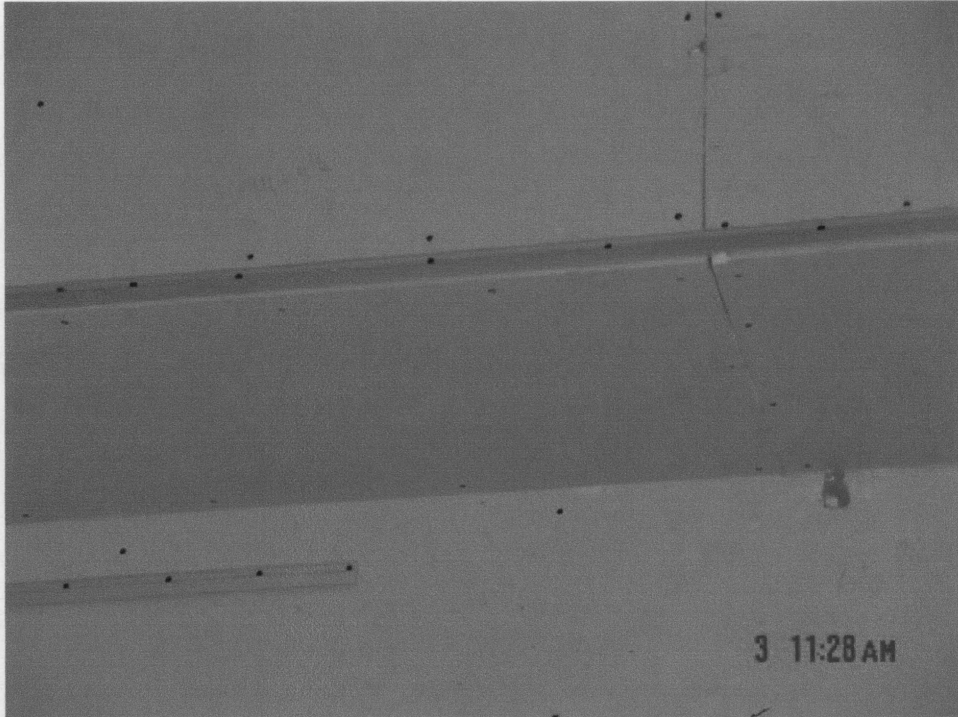
Photo 7: Aluminum Track Running Across Side Wall Below Soffit for Stretch Ceiling Installation.

1¼" X 3/8" aluminum track ran around the room 133" above the floor. This tracking was attached to the front and rear walls and below the two soffits that ran along the right and left walls. The tracking was used to install the New Mat (white in color) 15' X 15' stretch ceiling sample for testing.

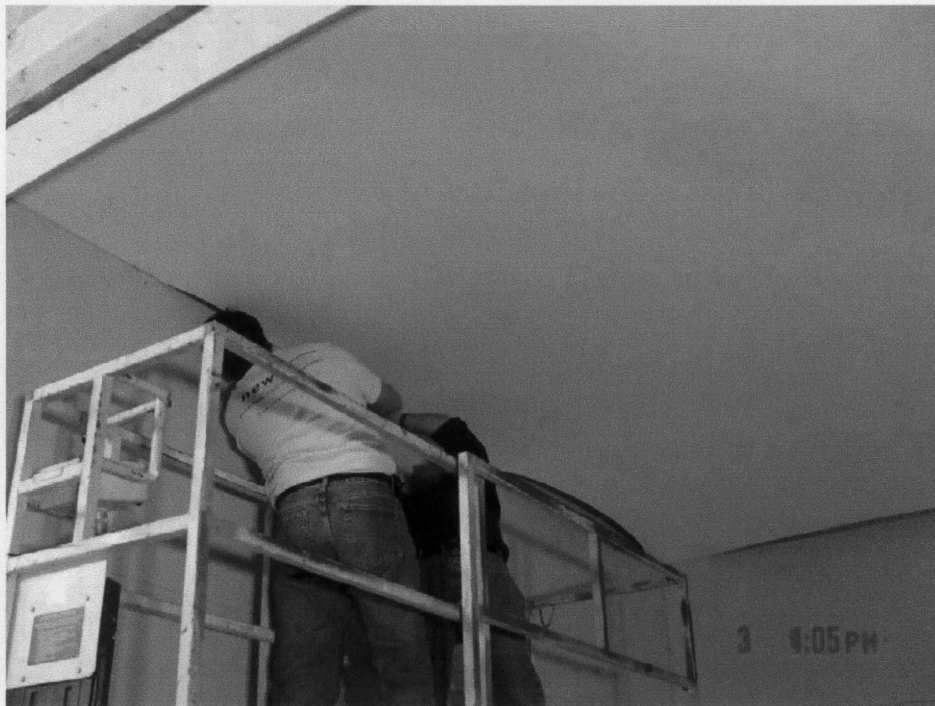
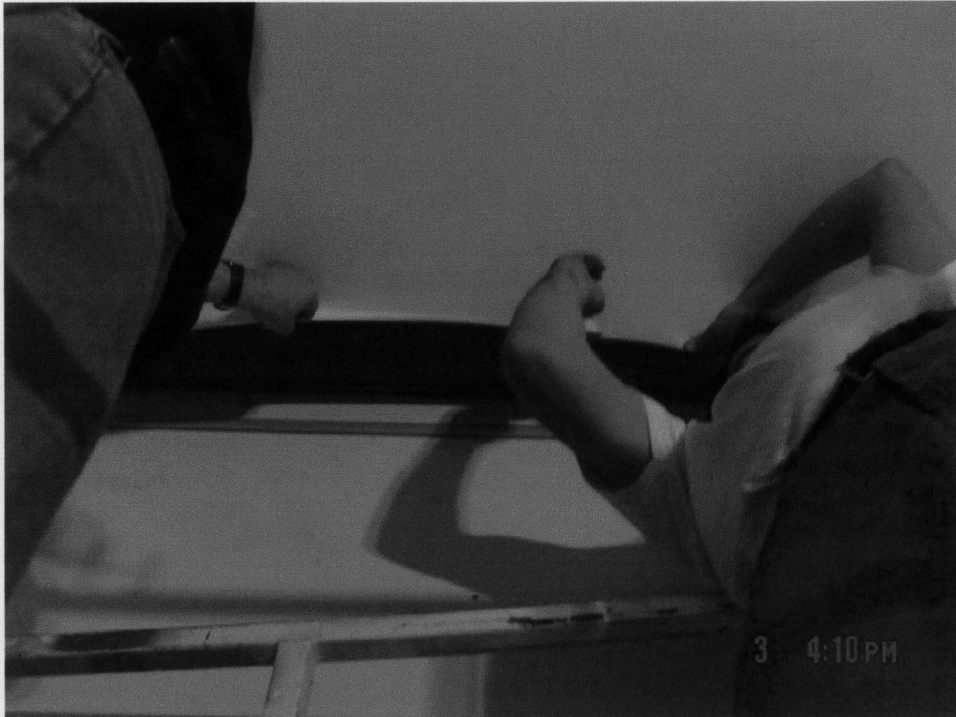
Photo 8: Installation of Stretch Ceiling Material.

Photo 9: Installation of Stretch Ceiling Material.

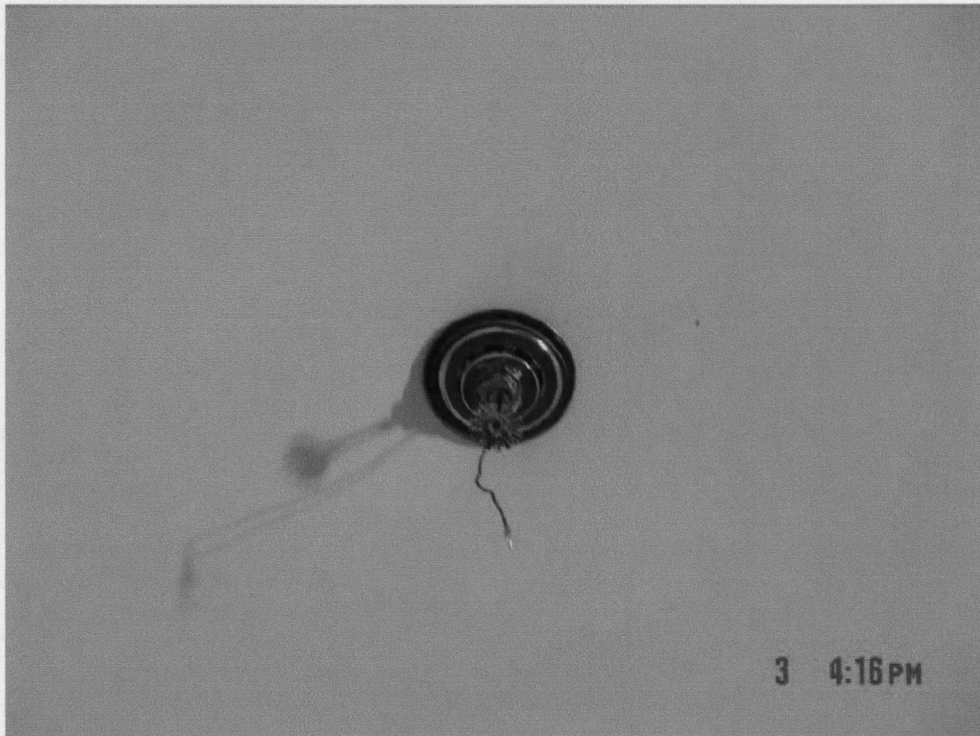
Photo 10: Sprinkler and Thermocouple #6 Coming Through Center of Stretch Ceiling.

The heads located at TC #1, #2, #4 and #5 were deactivated during this test. The head located at TC #3 was a 286° quick-response sprinkler and the head located at TC #6 was a quick-response 155° sprinkler.

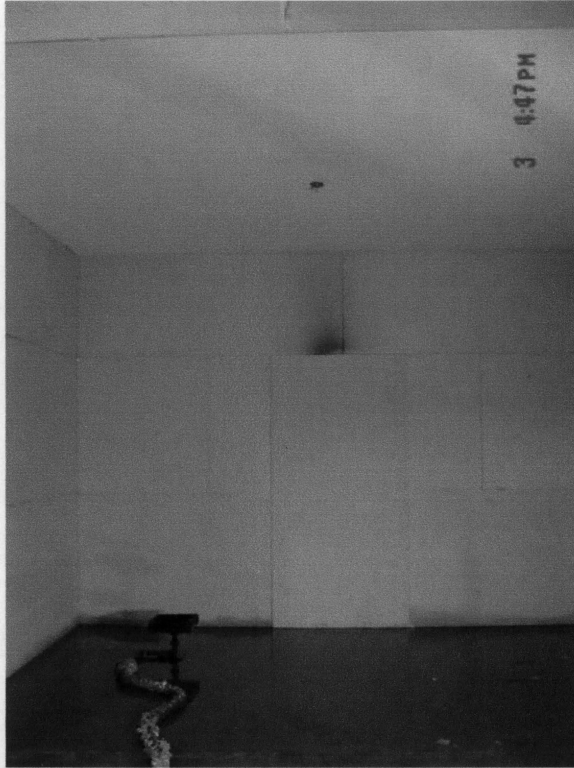
Photo 11: Square Burner Placed in Corner for Test.

A standard ceramic 1ft² square burner was placed in the corner of the room, 3'-6" from the left wall and 3'-6" from the back wall. It was set at a Heat Release Rate 160kW for the first 5 minutes of the test and at 250 kW for the remainder of the test.

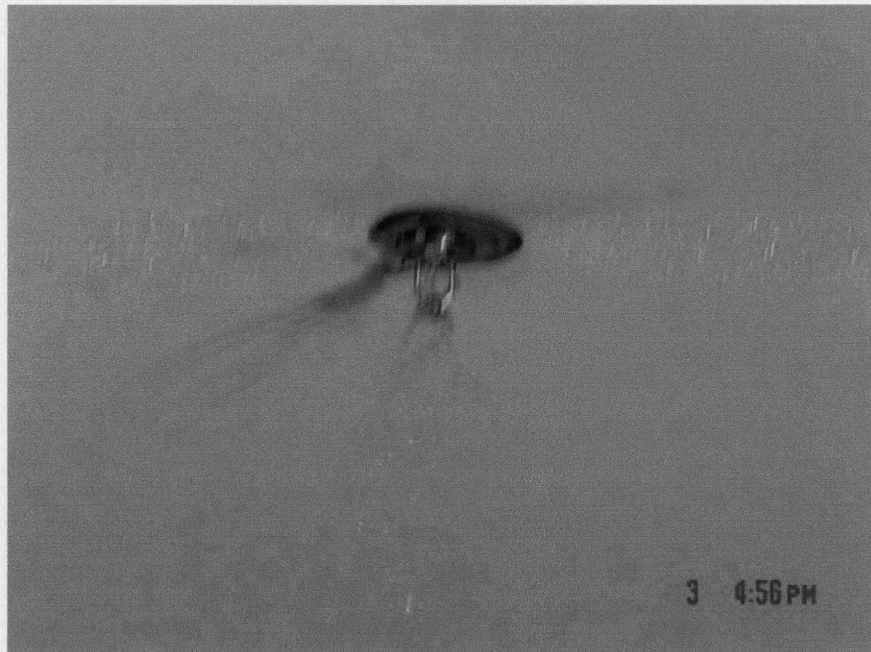
Photo 14: Sprinkler #6 Activated, Ending Test.

Test Time (h:mm:ss)	Event
0:00:00	Light burner, output of burner set at 160kW(HRR)
0:01:00	No change
0:02:00	No change
0:03:00	No change
0:04:00	No change
0:05:00	Increase burner to 250 kW
0:05:14	Sprinkler #6 activated, End Test
