**CLIENT:** **NEWMAT USA, LTD.**  
81 Mahan Street  
West Babylon, NY 11704

| <b>Test Report No:</b> | <b>TJ3159</b> | <b>Date:</b> | <b>August 28, 2015</b> |

**SUBJECT:** Flammability Testing to NFPA 286, Standard Methods of Fire Tests for Evaluating Contribution of Wall and Ceiling Interior Finish to Room Fire Growth – 2015 Edition.

**PRODUCT EVALUATED:** Client refers to samples received as “**M15 Panel**”. This project was entered into our receiving system on August 10<sup>th</sup>, 2015 in good condition.

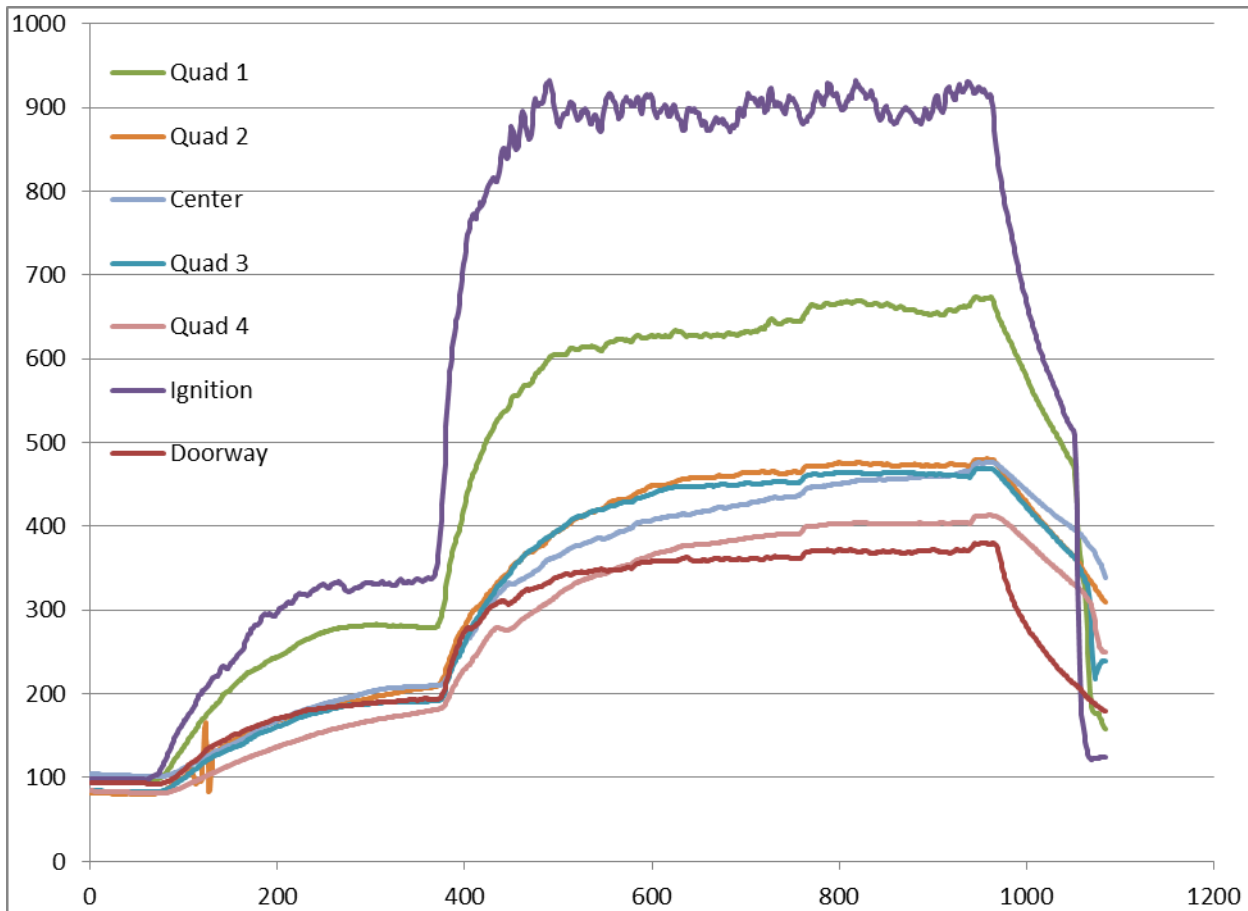
**FIGURE 2. Temperature vs. Time**

**Temperature vs. Time Chart:**

**Maximum Peak Temperatures:**

| Doorway | 380° F (193° C) |
| Center | 476° F (247° C) |
| Quadrant I | 674° F (357° C) |
| Quadrant II | 480° F (249° C) |
| Ignition | 933° F (501° C) |
| Quadrant III | 469° F (243° C) |
| Quadrant IV | 413° F (212° C) |

**PEAK AVERAGE UPPER LAYER TEMP – 547°F (286°C)**

- Peak Heat Release Rate of 181 kW
- Heat Flux at floor – Peak of 2.7 kW/m<sup>2</sup>
- Average upper average temperature – 547°F (286° C)
- Flames did not exit doorway
- Both paper targets undamaged during test

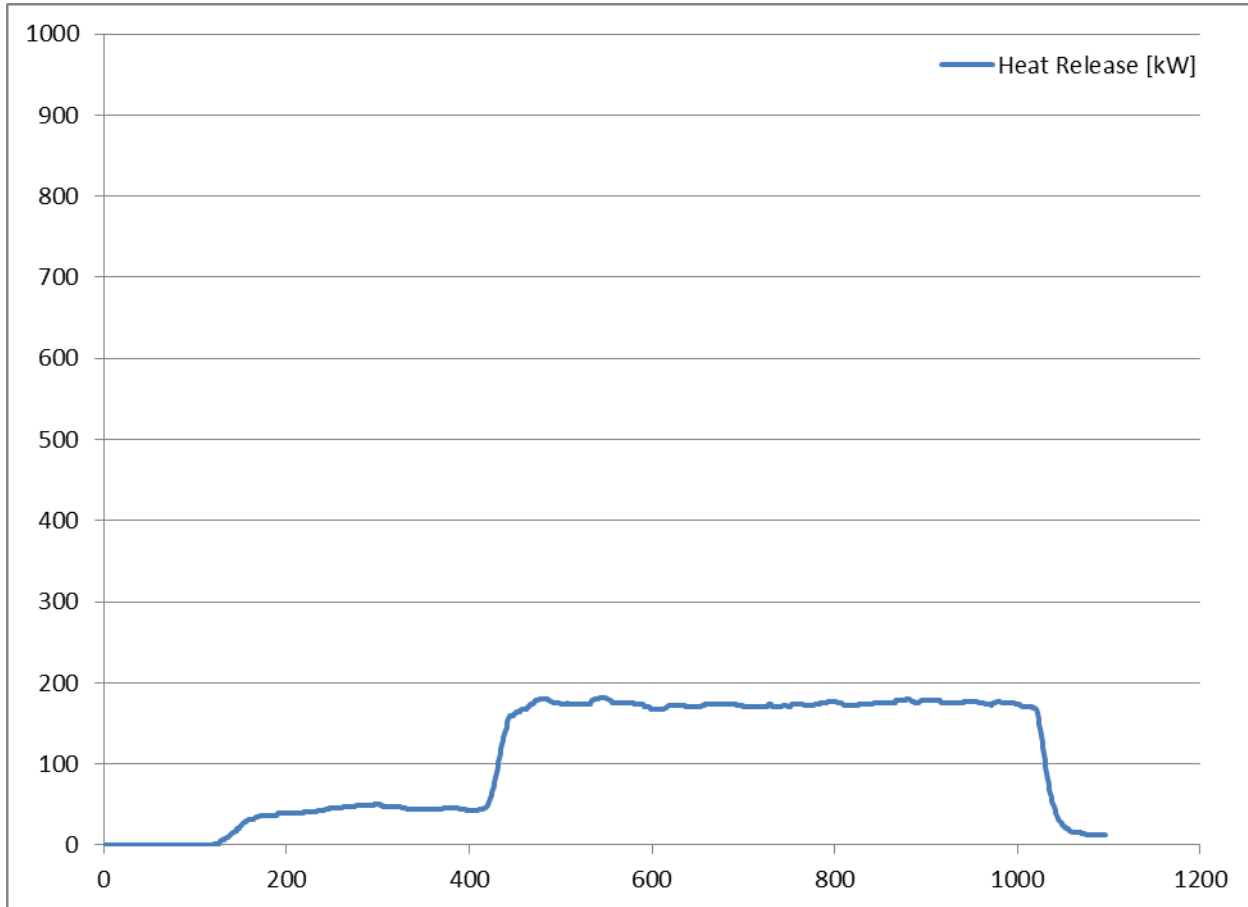
**FIGURE 3. Heat Release Rate vs. Time**

**Heat Release Rate vs. Time Chart:**

**Numerical Values:**

| 0-5 min average (kW) | 43 |
| 5-15 min average (kW) | 174 |
| Peak Heat Release Rate | 181 kW @ 5:55 |
| Total Heat Released During 15 min Test | 118 |

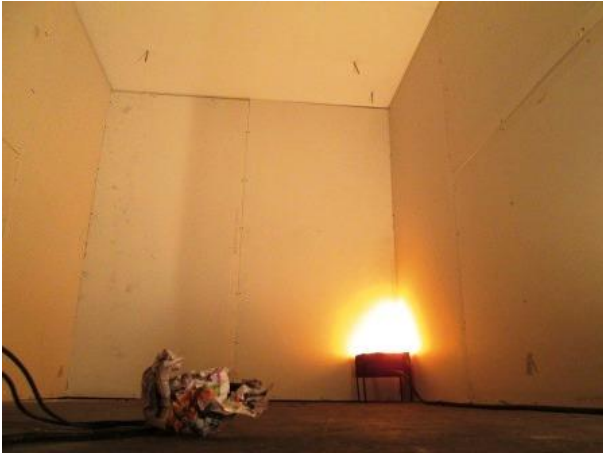
Test Start

- 0:00:00 – Sand diffusion burner lit to 40 kW flame
- 0:01:00 – Very light smoke and no contribution from assembly other than melting away from flame
- 0:02:00 – Flame height leveling off at around 4 feet from floor

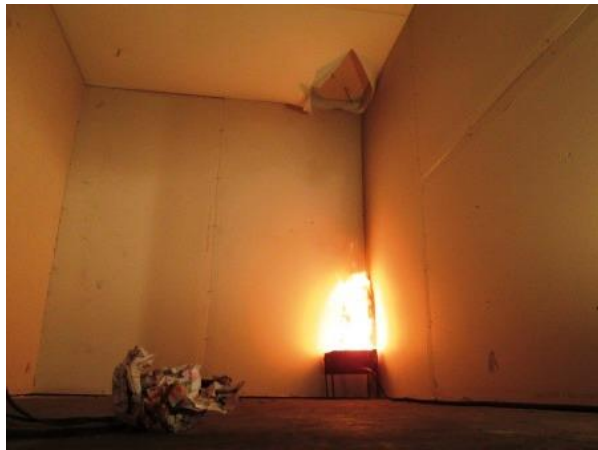
After 3 Minutes

- 0:03:00 – Continued light smoke development, very little contribution from assembly
- 0:04:00 – Little change in conditions above, most of test panel closest to burner melted away

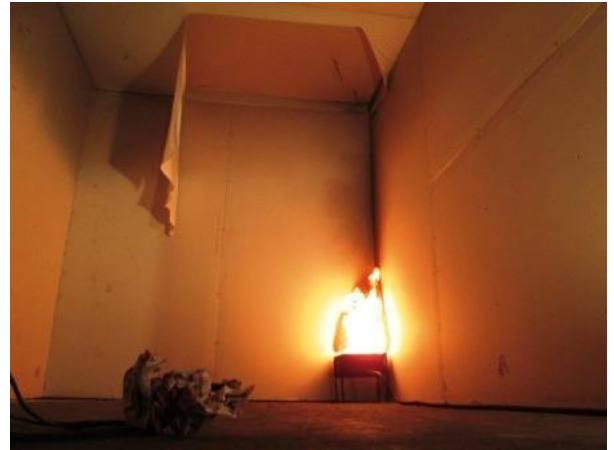
At 5 minutes

- 0:05:00 – Sand diffusion burner increased to 160 kW flame
- 0:06:00 – Slight smoke increase, flames from burner hitting ceiling
- 0:08:00 – Minimal contribution of flame from walls, smoke light in color

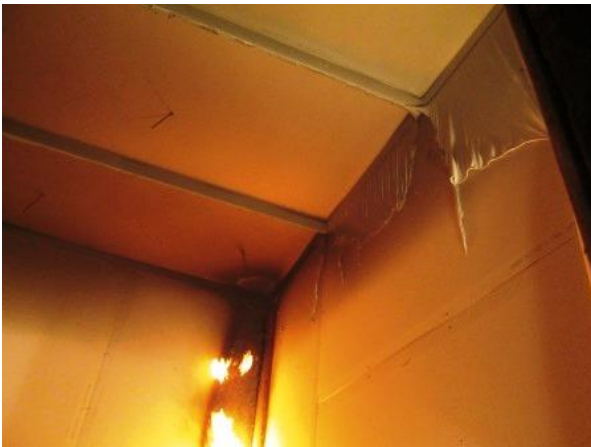
After 13 Minutes

- 0:10:00 – Little change in conditions above, most of material is melted away from flames
- 0:12:00 – Flame intensity and smoke development steady
- 0:13:00 – Continued steady performance, very little visible contribution from assembly

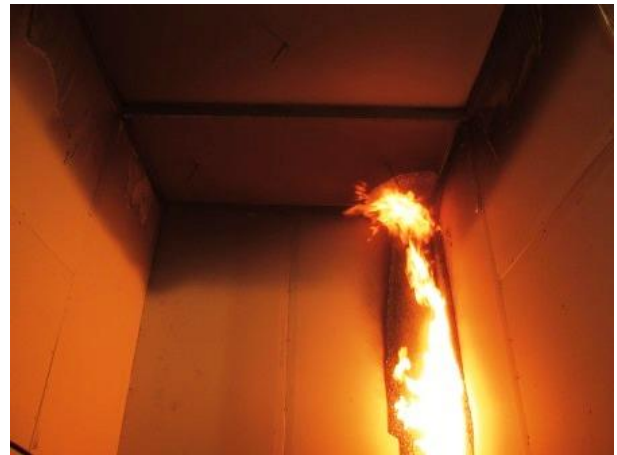
After 15 Minutes

- 0:14:00 – Fairly steady flame intensity and smoke developed throughout test
- 0:15:00 – NFPA 286 test complete, flames immediately self-extinguish after gas shut off

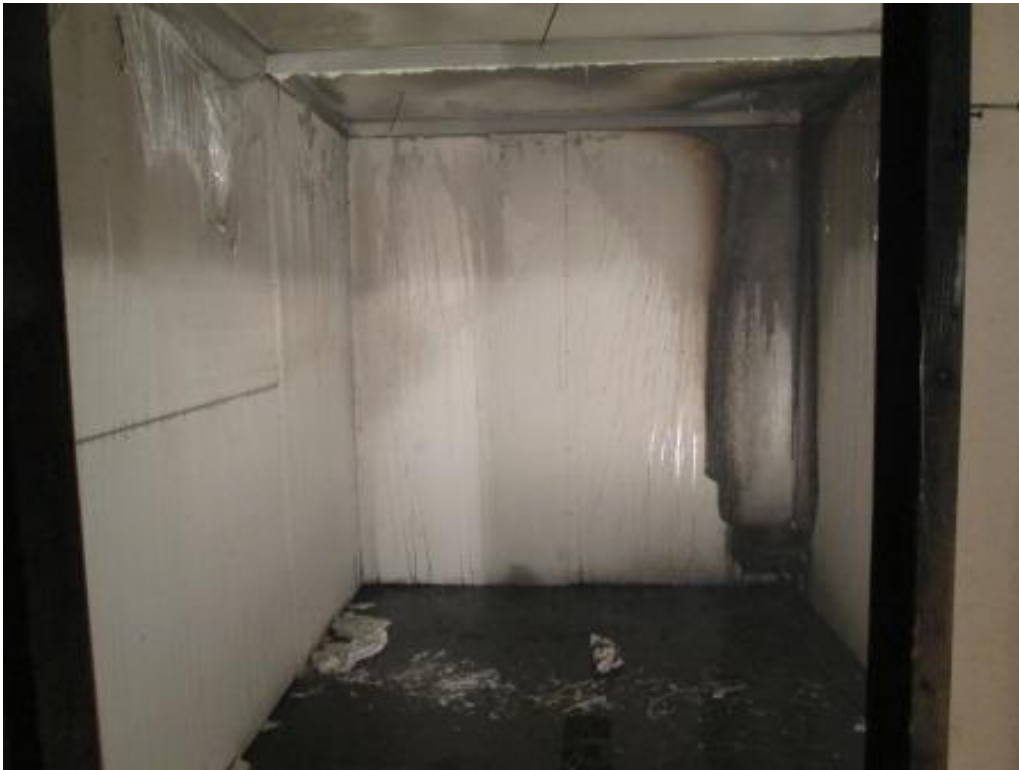
Photos Immediately After Test

All charring as a result of testing this assembly was limited to the corner of the burner placement and specific to the drywall only. There was a “V” pattern of char in the corner of ignition that went all the way to the ceiling, starting at the burner and ending up charring a section measuring approximately three feet in both directions to the ceiling. The ceiling itself had slight soot deposition as was each of the three walls measuring approximately 2 feet down from the ceiling.
