INVESTIGATION OF THE INTERNAL ROOM FIRE CHARACTERISTICS OF A 5-MIL THICK REINFORCED PVC MEMBRANE CEILING TESTED IN GENERAL ACCORDANCE WITH UBC STANDARD 26-3, "ROOM FIRE TEST STANDARD FOR INTERIOR OF FOAM PLASTIC SYSTEMS"

FINAL REPORT

SwRI Project No. 01.03050.01.211a[1]

Newmat USA
25 Surryhill Place
Huntington, New York 11743

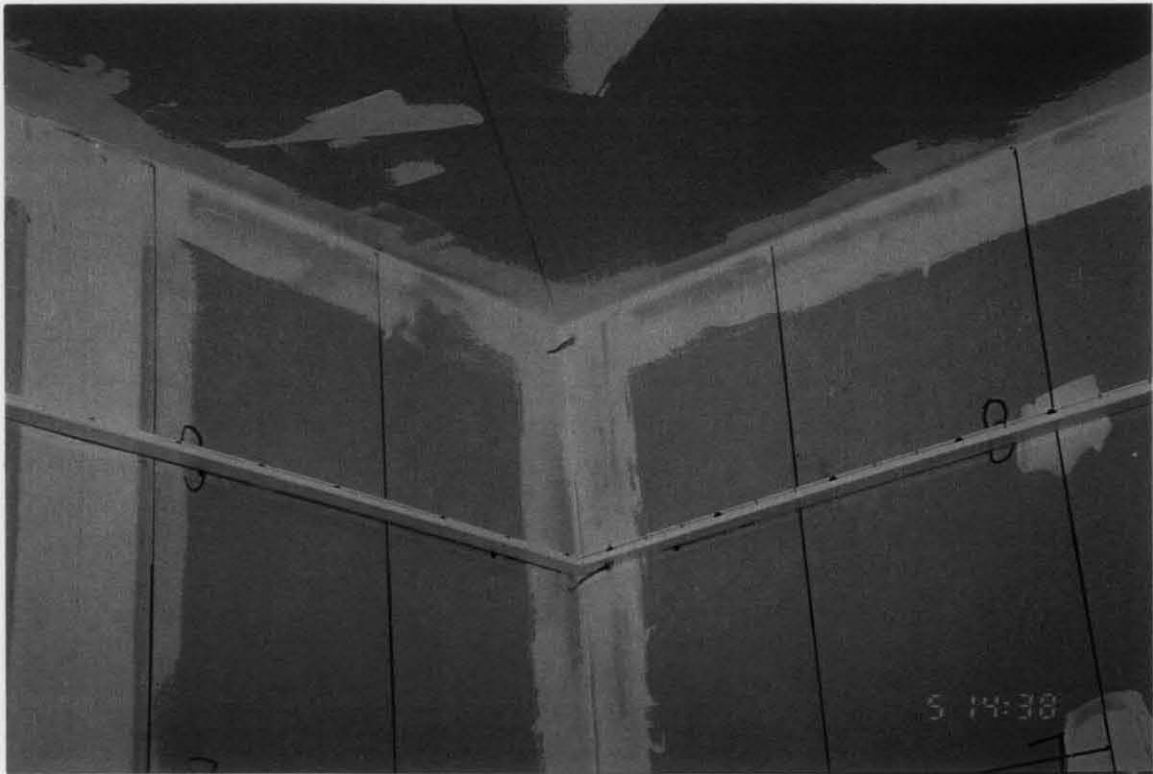
Figure B-1. View of Crib Corner at the Wall/Ceiling Intersection. Aluminum Angle is Mounted 12 in. Below Gypsum Ceiling Around Interior of Room.

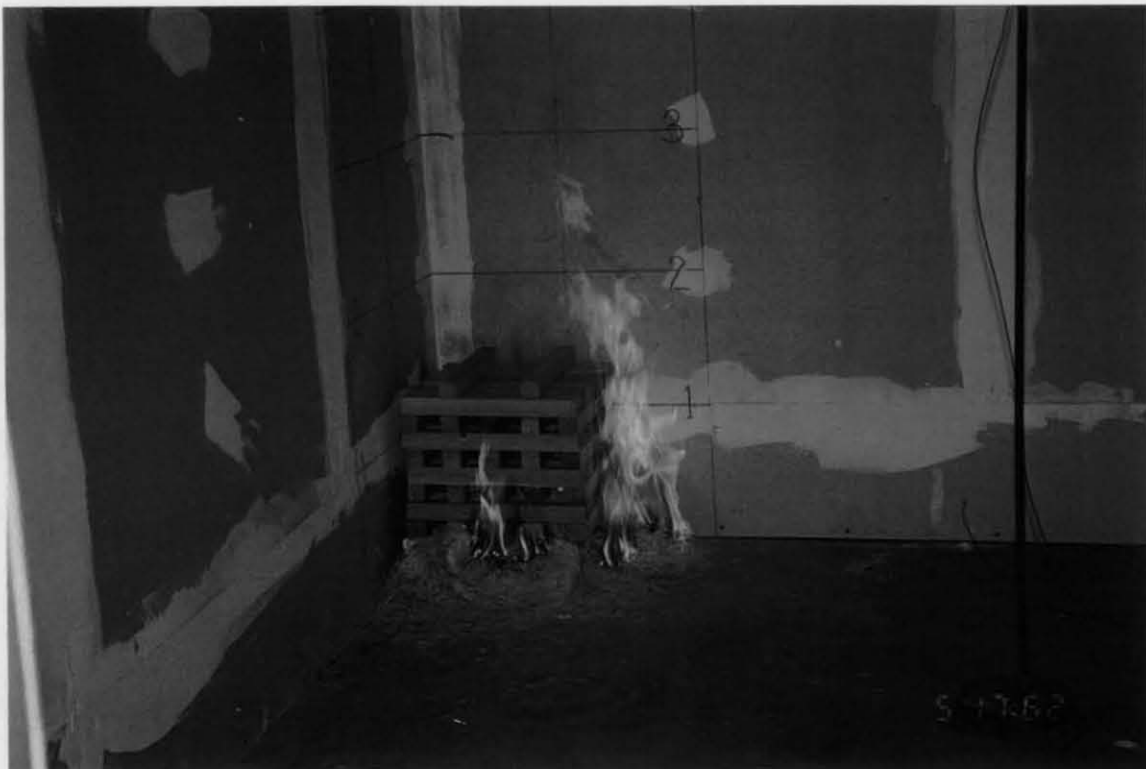
Figure B-4. Start of 15-Min. Fire Exposure With Ignition of Excelsior Under 30 lb Wood Crib.

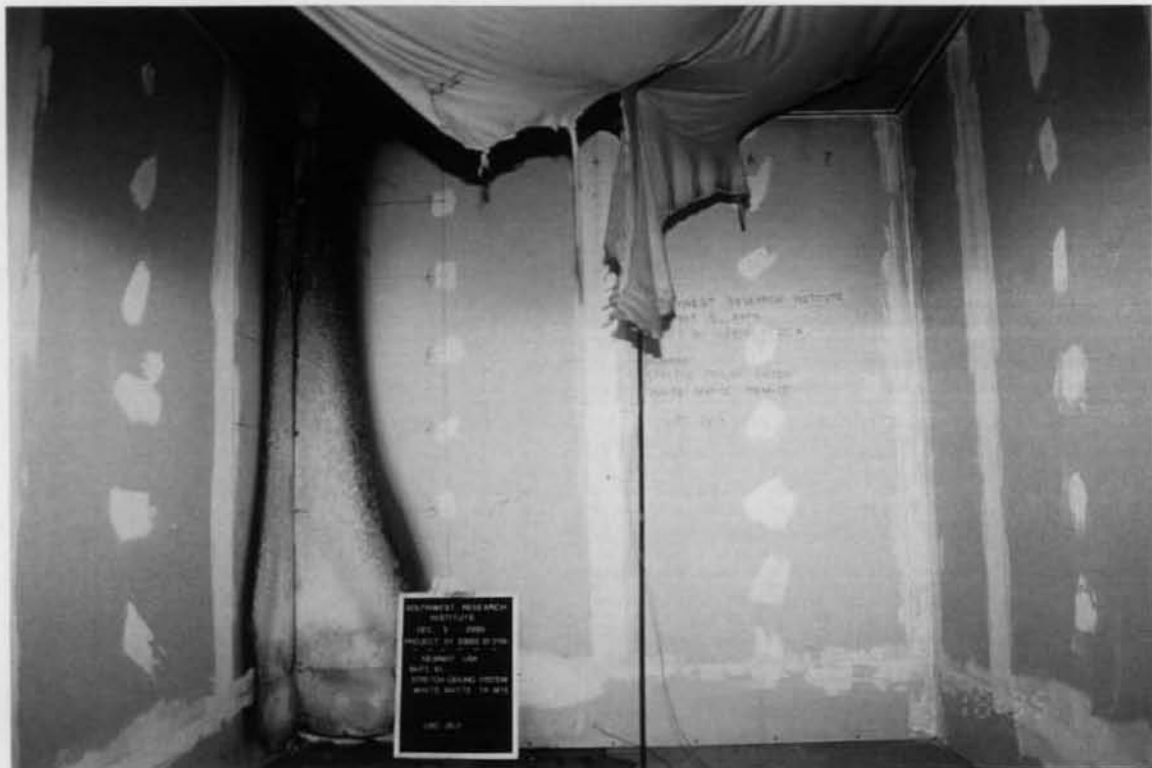
During the initial course of the 15-min fire exposure, flames and heat from the burning crib softened and melted the reinforced PVC membrane initially forming a small hole to develop in the ceiling corner. All four sprinkler heads installed in the room interior activated. By the end of the 15-min fire exposure, the reinforced PVC membrane melted/tore away in the crib corner approximately 8-ft along both walls which formed the crib corner, and hung down 5½ ft above the floor.

Figure B-11. Room Interior with Crib Removed.
